THIELSCH ENGINEERING, INC.

**METALLURGICAL EXAMINATION OF
STRESS CORROSION CRACKING
IN BOTTOM ASH SEAL CURTAIN SECTION
UNIT NO. 2
INTERMOUNTAIN GENERATING STATION
INTERMOUNTAIN POWER COMPANY
DELTA, UTAH**

March 3, 1993

Report No. 5455

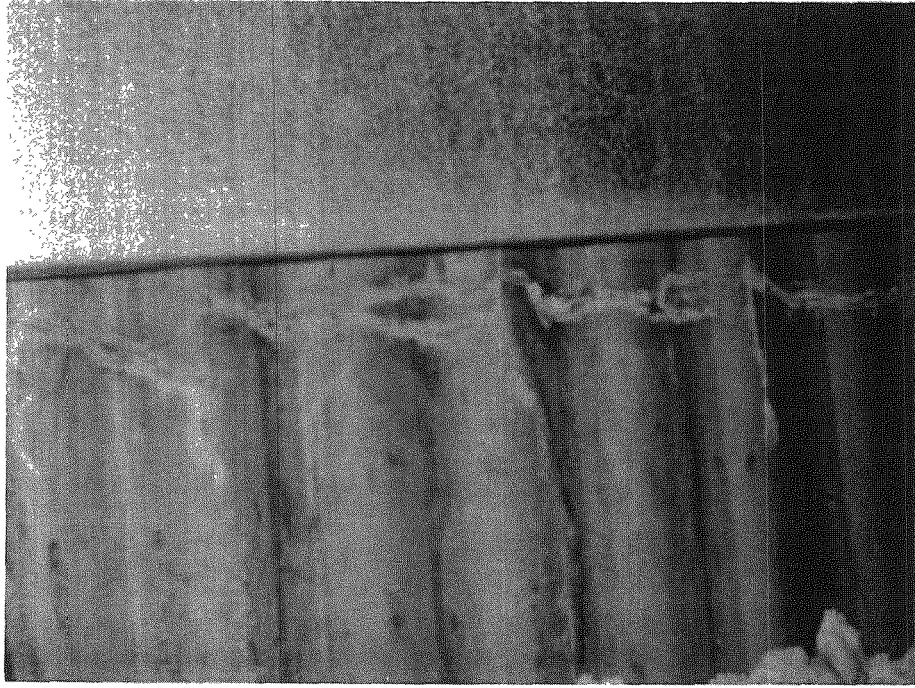
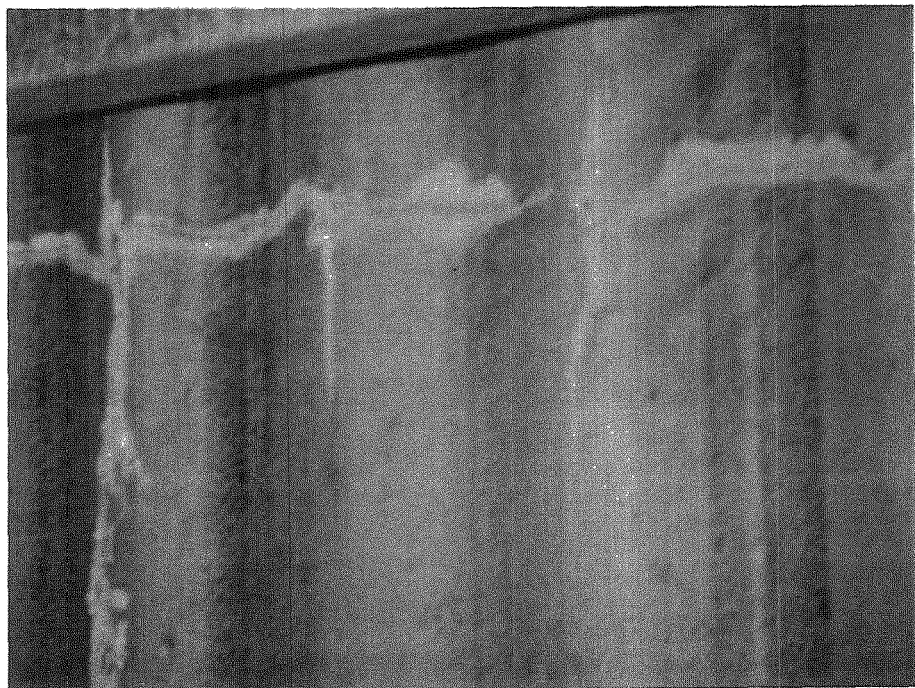
A visual examination of the as-received materials was performed. Fig. 1 shows an engineering drawing illustrating the location of the seal curtain and its relative location to the remainder of the boiler components. Photographs provided by plant personnel are presented in Figs. 2 through 4 depicting the Unit No. 2 seal curtain cracking. Cracking was observed in the vertical and horizontal directions.

Fig. 2. Overall views of the bottom ash seal curtain cracks (outer surface).

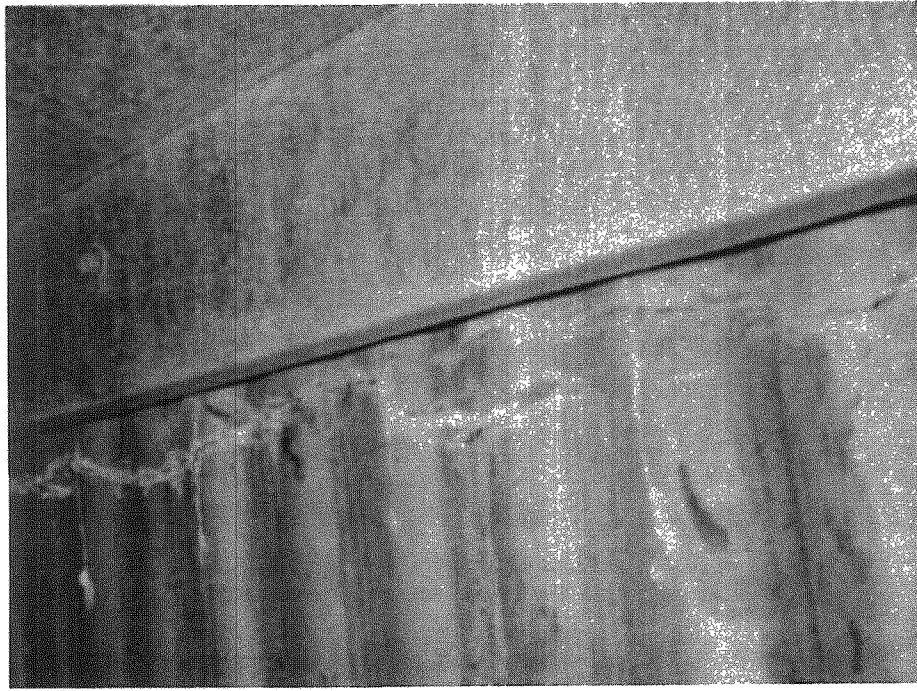
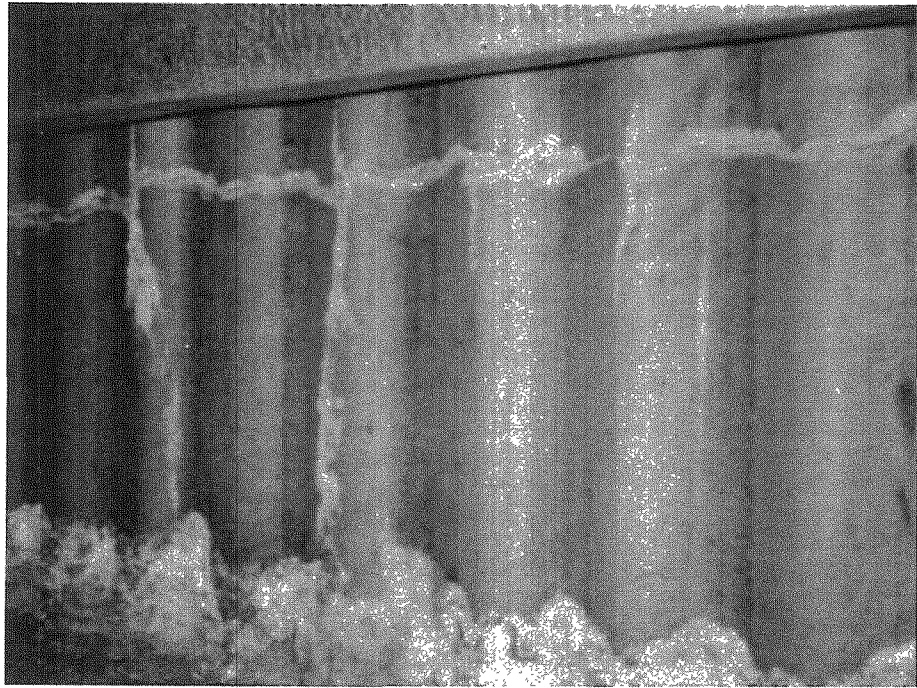
Fig. 3. Additional views of the bottom ash seal curtain cracks (outside surface).

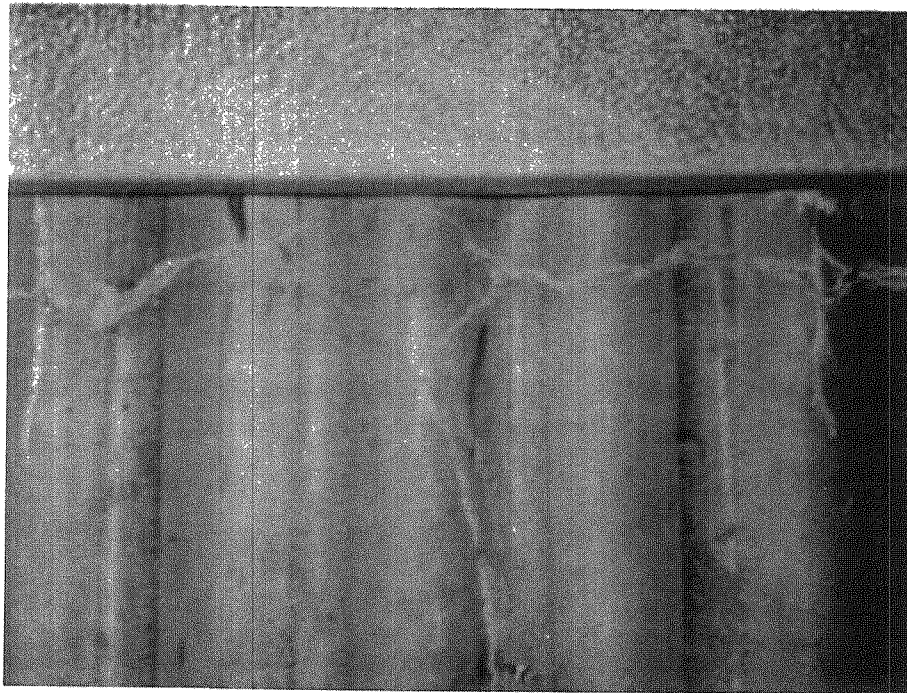
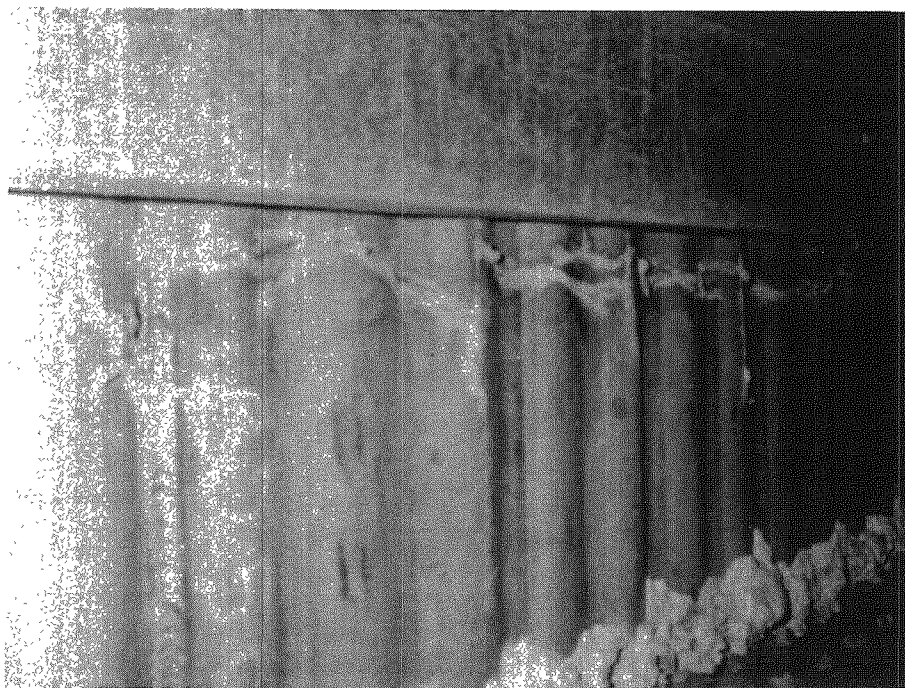
Fig. 4. Additional views of the bottom ash curtain cracks.

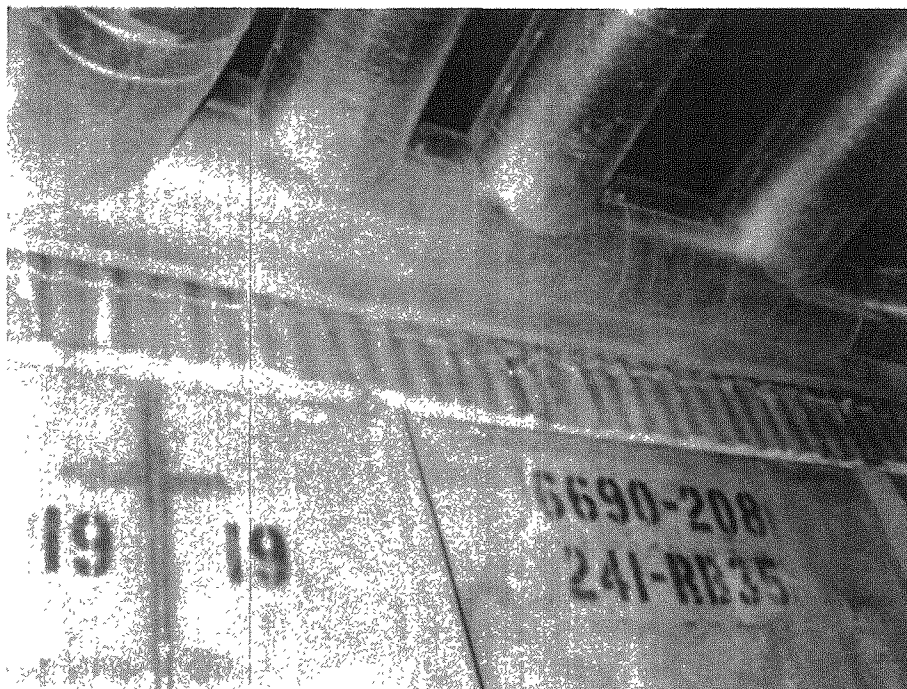
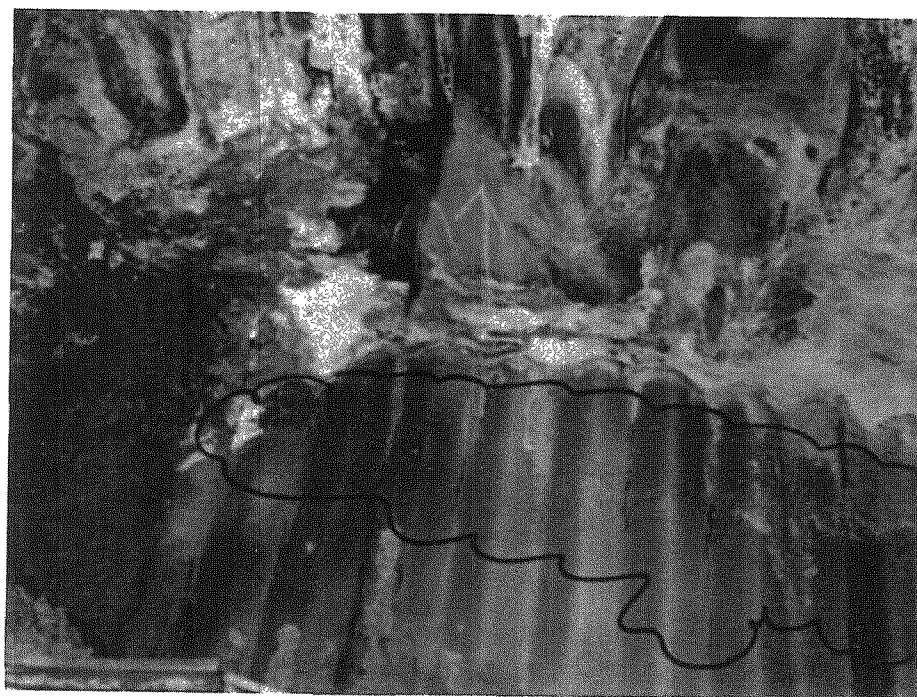
Fig. 5 illustrates initial cracking observed near the Unit No. 1 waterwall header (bottom photograph). A view of the boiler side of the seal curtain is provided. The top photograph shows an overall view of the cracking observed.

Fig. 5. Comparison of the Unit No. 2 seal curtain crack-
ing (top photograph) and initial stages of crack-
ing observed in Unit No. 2 (bottom photograph).

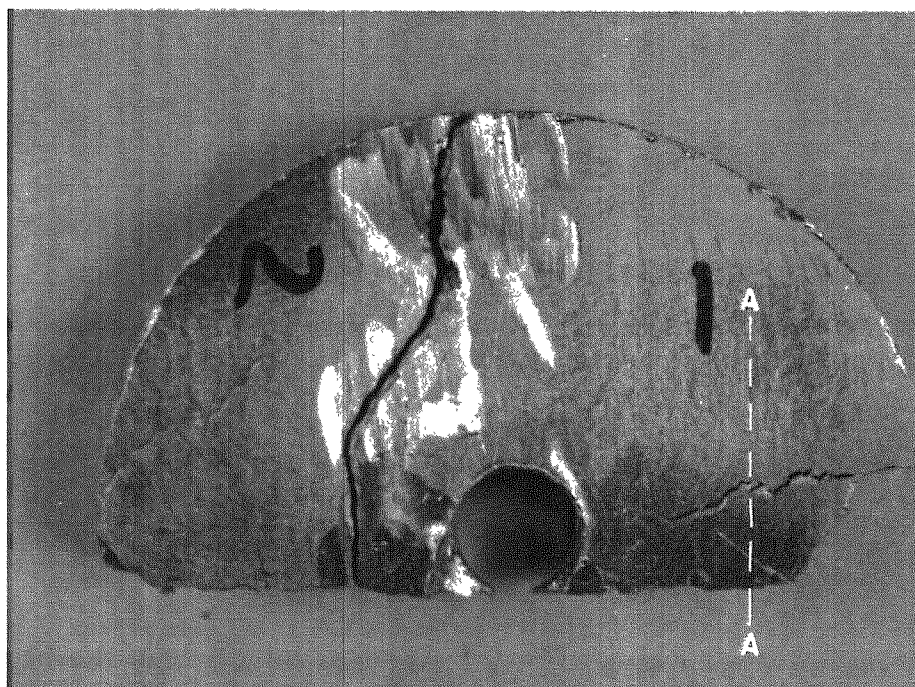
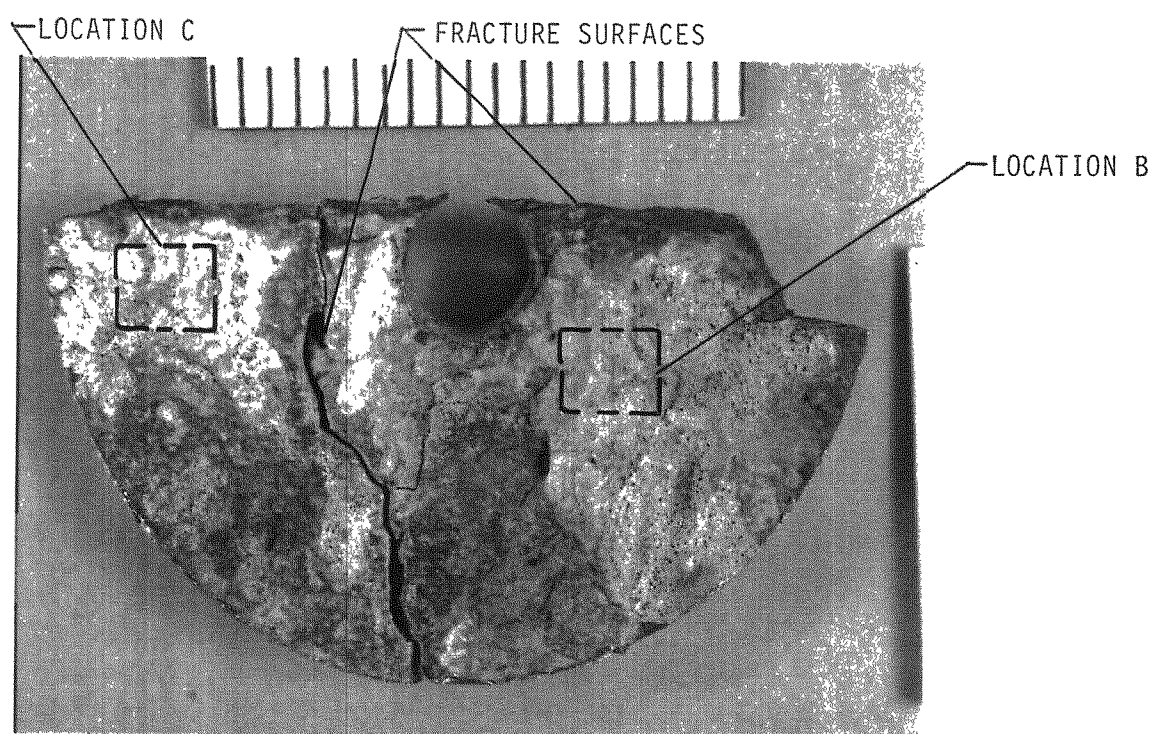
A small semicircular plug sample was removed from the seal curtain. The section received is shown in Fig. 6. The two sections were randomly identified as sections Nos. 1 and 2.

Energy Dispersive Spectroscopy (EDS) was also performed on the crack surface. Location B, identified in Fig. 6, shows the corrosion product analyzed by Energy Dispersive Spectroscopy (EDS). The results of the analysis are provided in Fig. 15. The primary contaminant was identified as sulfur (present as sulfates). Calcium, sodium, silicon, oxygen and chlorine (chlorides) were also present at this location. The remaining elements represent the base metal.

Location C is also identified in Fig. 6. Heavy surface scale was observed. The Energy Dispersive Spectral (EDS) plot is provided in Fig. 16. High levels of sulfur, chlorine, silicon, oxygen, calcium and potassium were detected. Iron, chromium and nickel represent the base metal.

Fig. 6. Overall views of sections received.

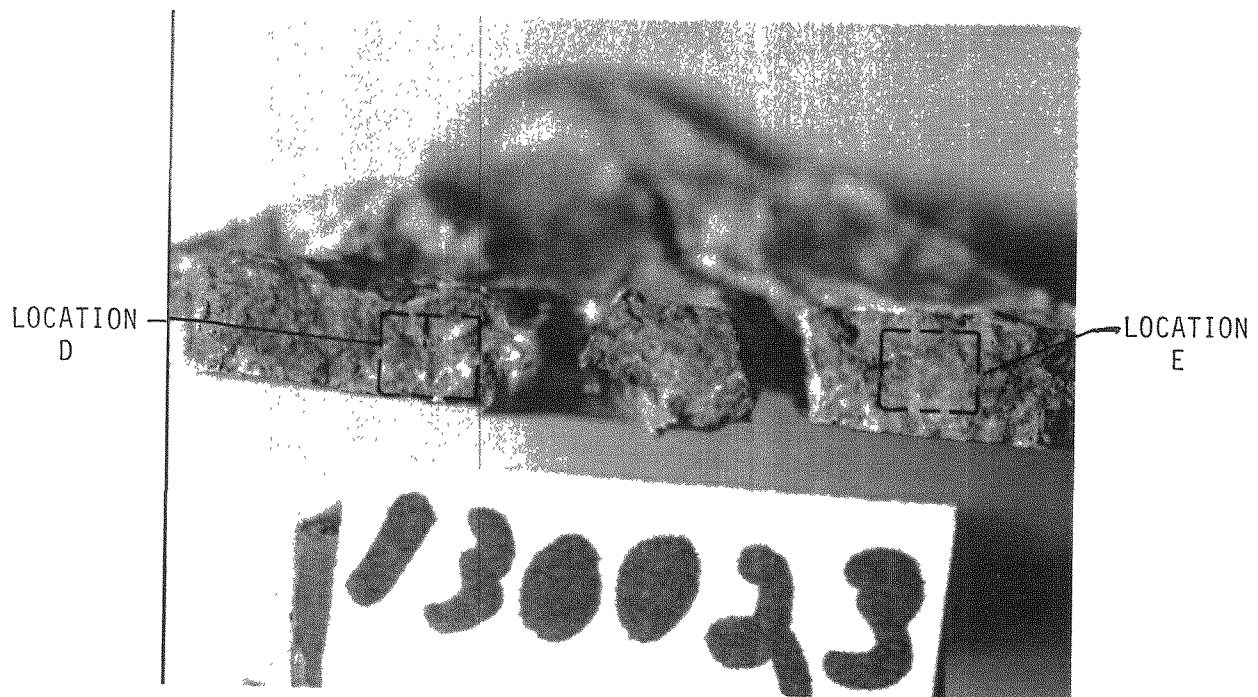
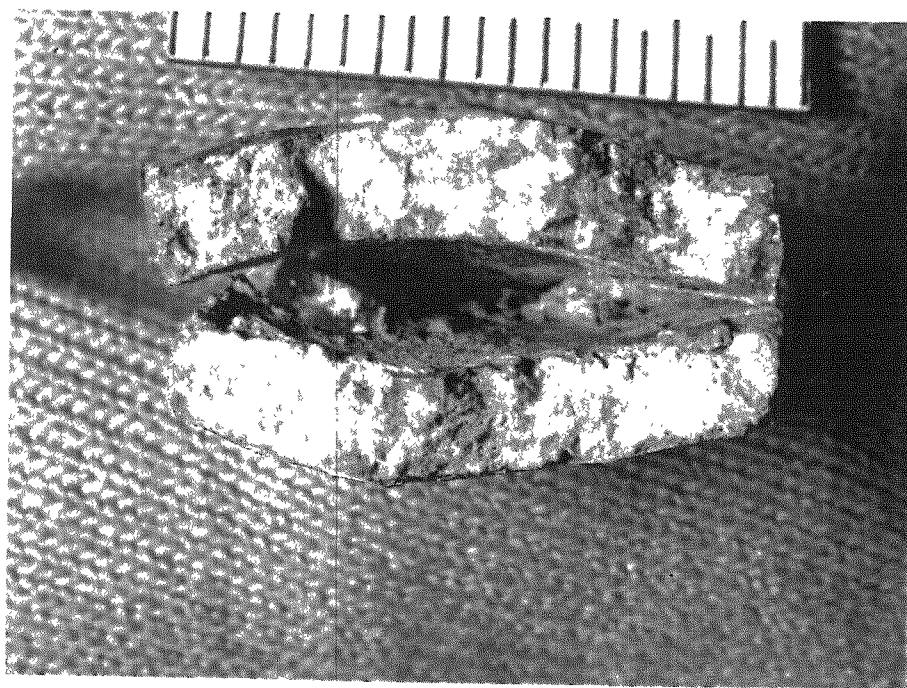
The fracture surfaces of sections Nos. 1 and 2 are shown in Fig. 7. Corrosion product covered the fracture surfaces. These areas were examined analytically for corrosive deposits and for fracture features.

Locations D and E on the fracture surface, identified in Fig. 7, were also examined. The Energy Dispersive Spectral (EDS) plots of the fracture surface deposits are provided in Figs. 17 and 18. Very high levels of sulfur and chlorine were detected on the fracture surface. These contaminants are highly corrosive to austenitic stainless steels materials.

Fig. 7. Close-up views of the fracture surfaces.

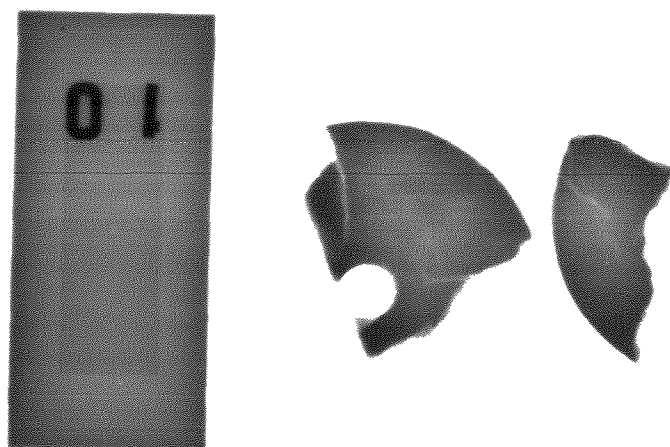
Radiographic examination was performed on the seal sections provided to further evaluate the extent of cracking. Fig. 8 shows a photographic print of the results. Evidence of secondary cracking was observed.

Fig. 8. Photographic print of radiographic film recorded of the sections received.

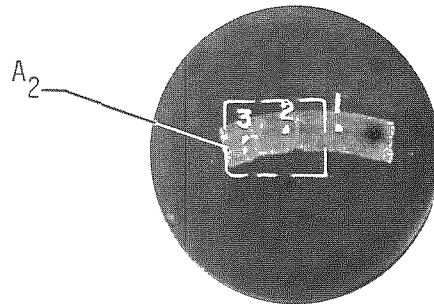
A metallurgical examination was performed to evaluate the metallurgical condition of the material and to determine the extent of cracking. Cross section "A-A", shown in Fig. 9, was mounted in bakelite, polished and etched for metallurgical evaluation. Rockwell B hardness determinations were performed at the locations indicated. The corresponding Brinell hardness values ranged from 191 BHN to 203 BHN.

Fig. 9. Overall view of subsegment cut at cross section "A-A". Rockwell "B" hardness determinations are also provided. The corresponding Brinell values are indicated in ().

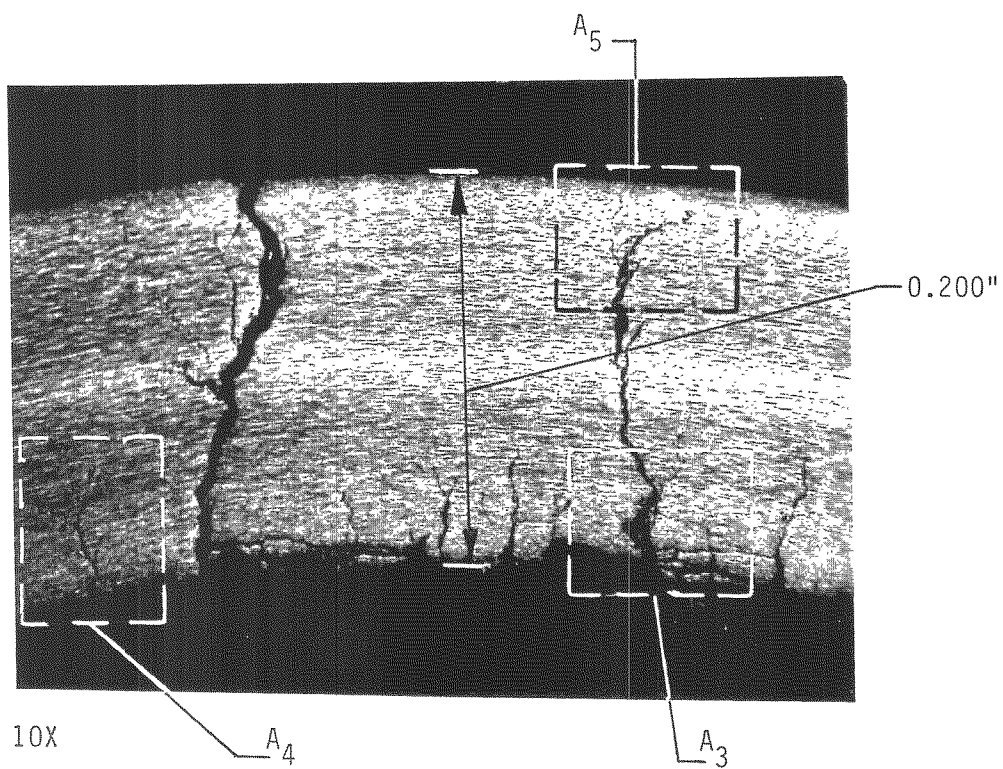
Fig. 10. Photomicrograph at "A₂".

A photomacrograph (magnification 10X) of location "A₂" is provided in Fig. 10. Stress corrosion cracking was evident through the wall thickness of the material. The total wall thickness measured 0.200". Additional areas were selected for examination to verify the cracking mechanism.

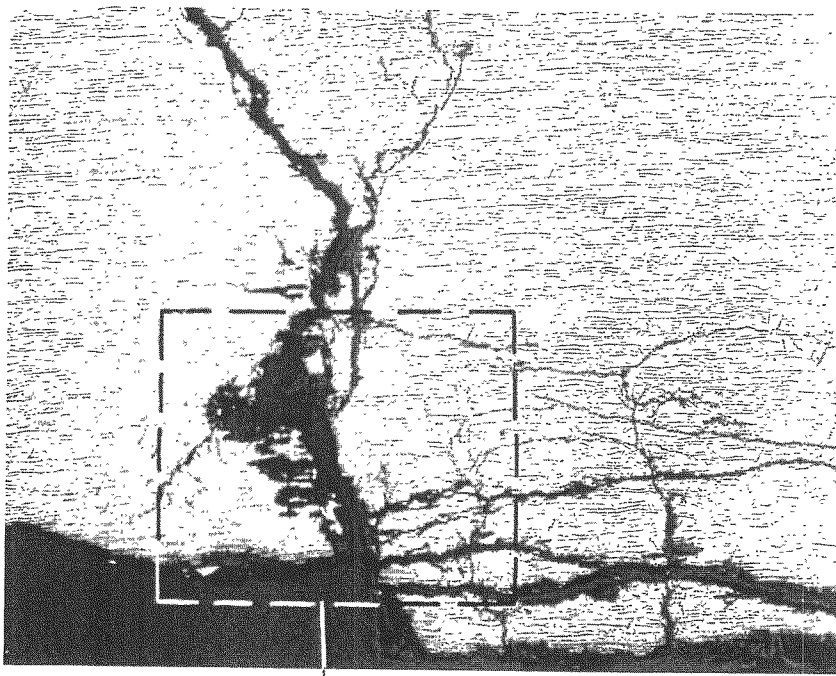
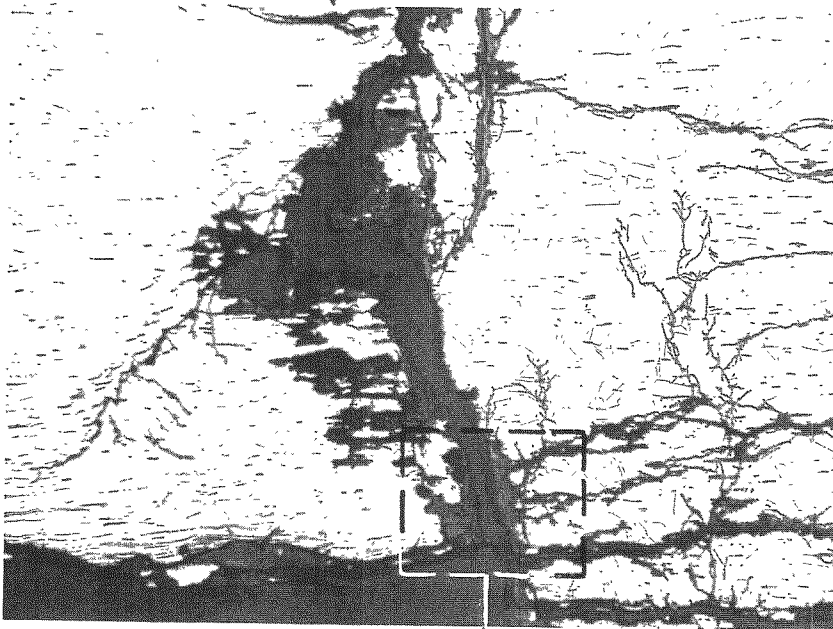
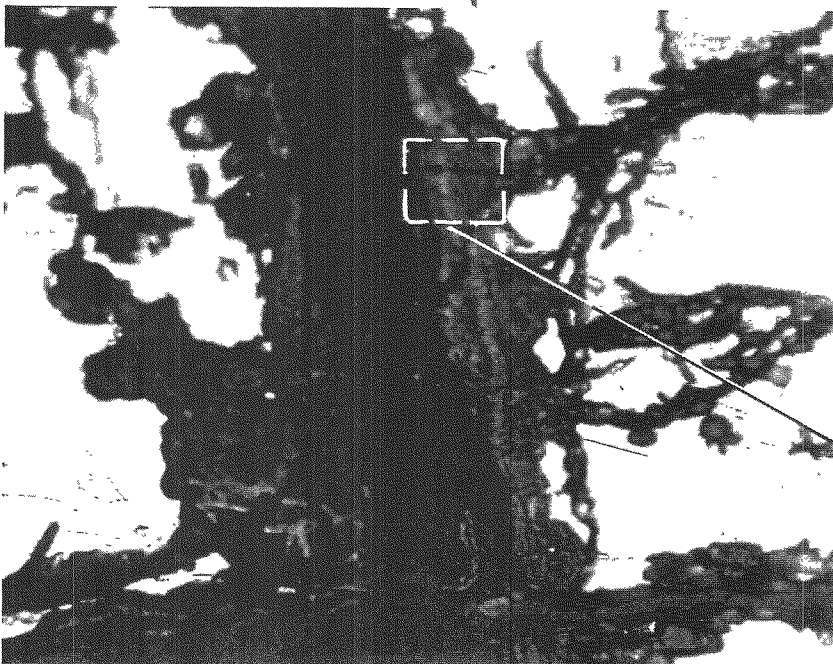
Microstructure at "A₃".

Fig. 11 illustrates the microstructure at location "A₃".

The microstructure consisted of austenitic grains with intergranular and transgranular cracking initiating on the internal surface. Extensive branch cracking was evident in the microstructure.

An analysis of the scale deposits in the crack penetrations was also performed. These areas are identified as locations F and G in Figs. 11 and 12 respectively. The analysis

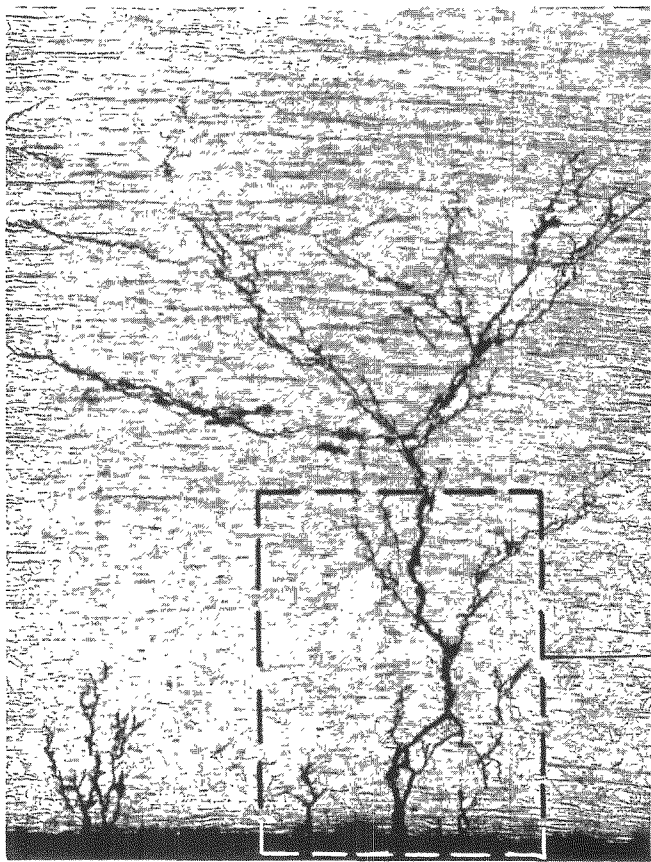
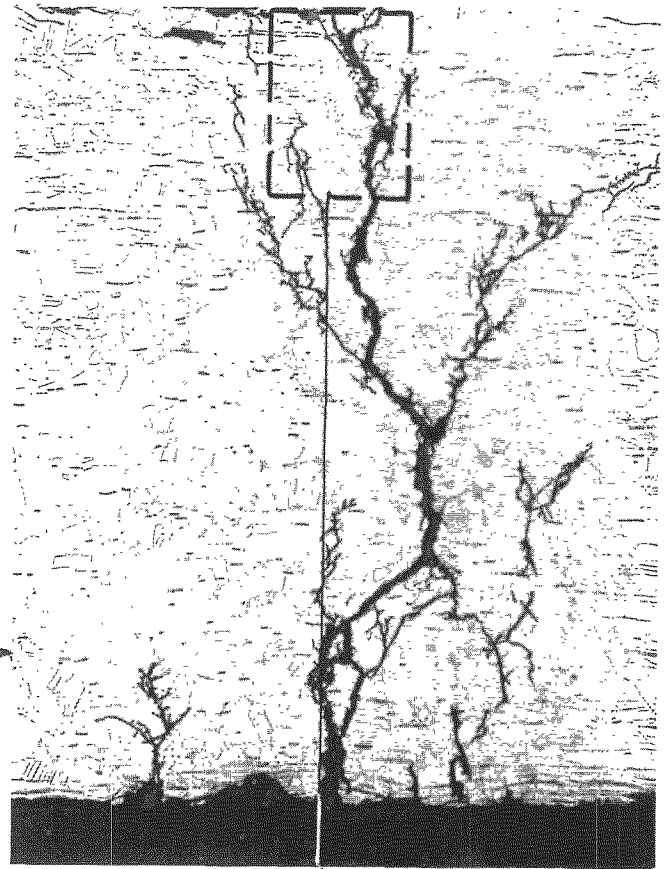
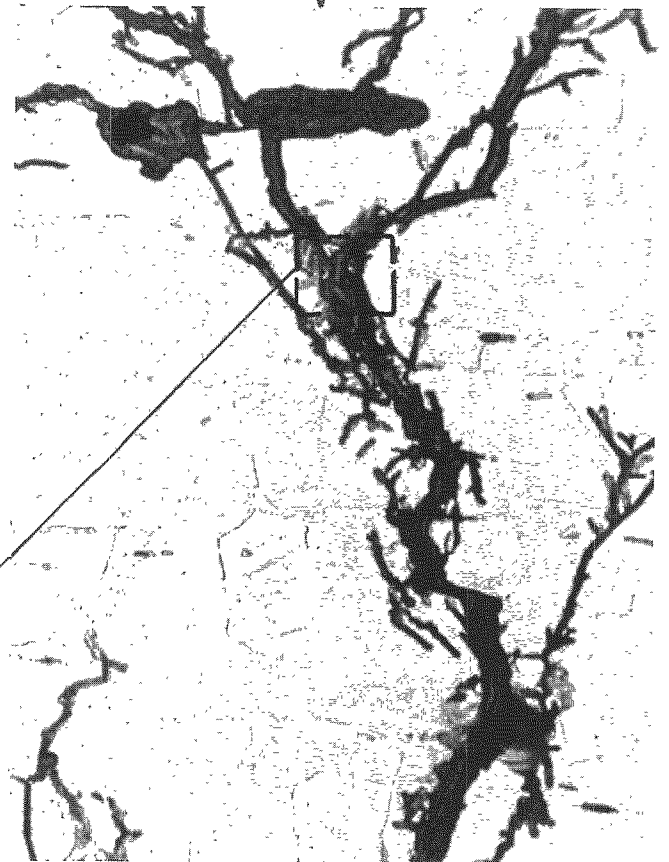
Fig. 12. Microstructure at "A₄".

Location "A₄" is shown in Fig. 12. Additional views of the branch cracking were observed. Scale was evident throughout the crack surfaces. Secondary crack initiation was also apparent on the internal diameter.

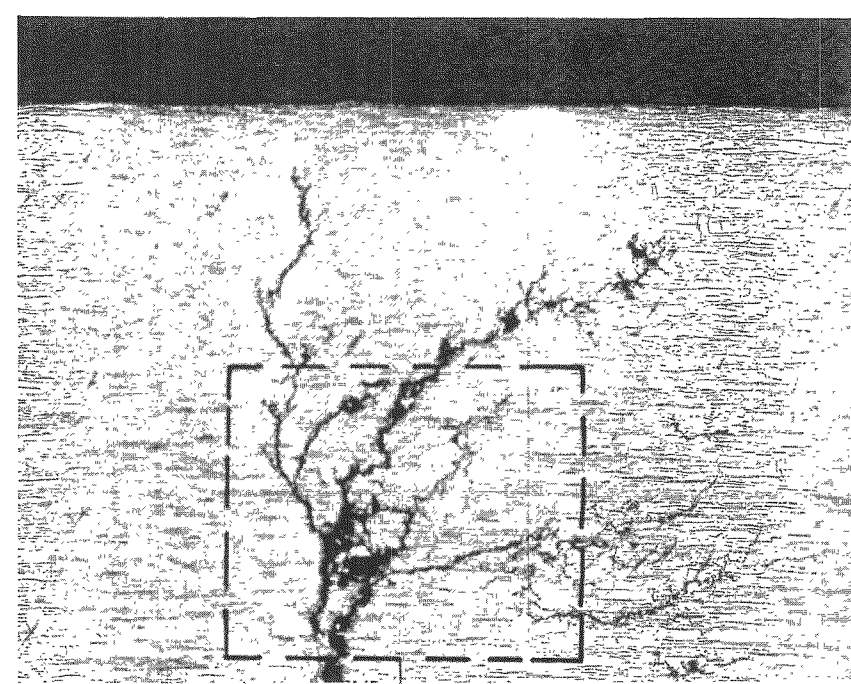
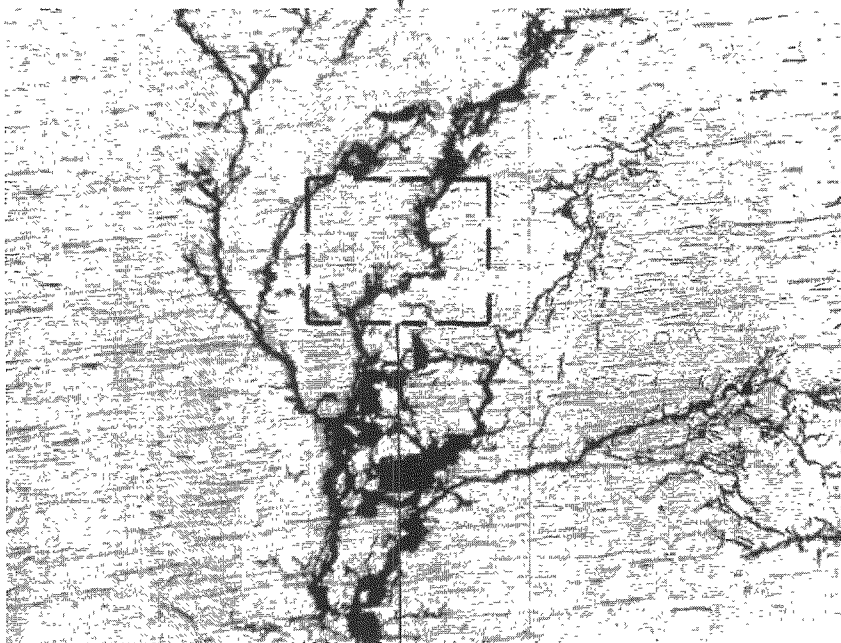
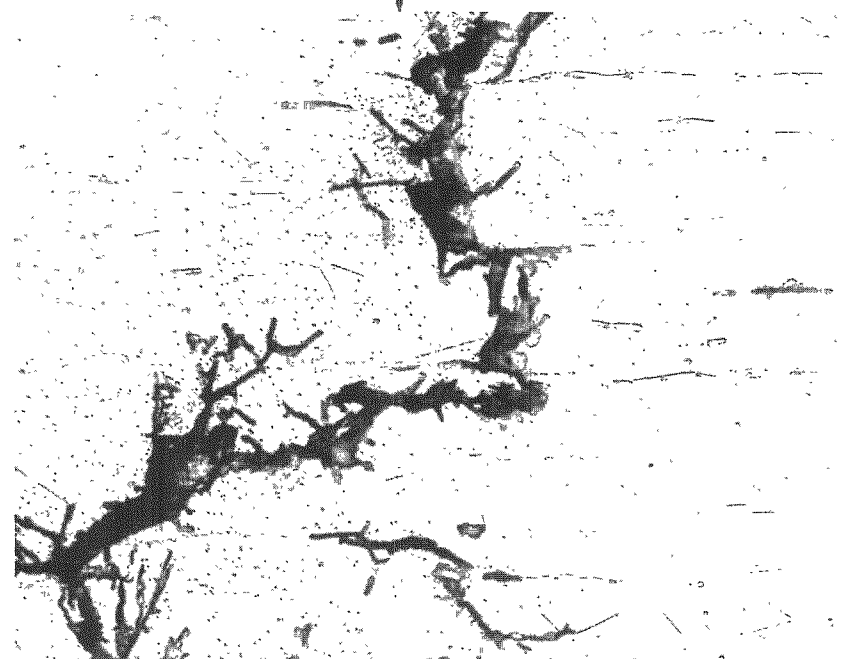
Microstructure at "A₅".

The crack tips also showed scale product at location "A₅", Fig. 13. The presence of scale in the crack indicates an environmentally induced cracking mechanism. The microstructure consisted of austenitic stainless steel grains.

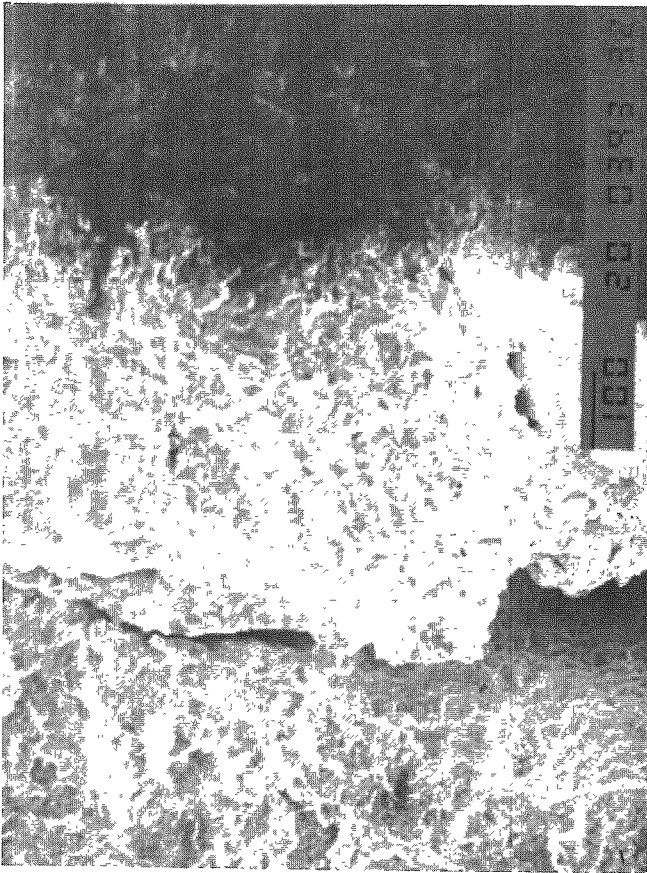
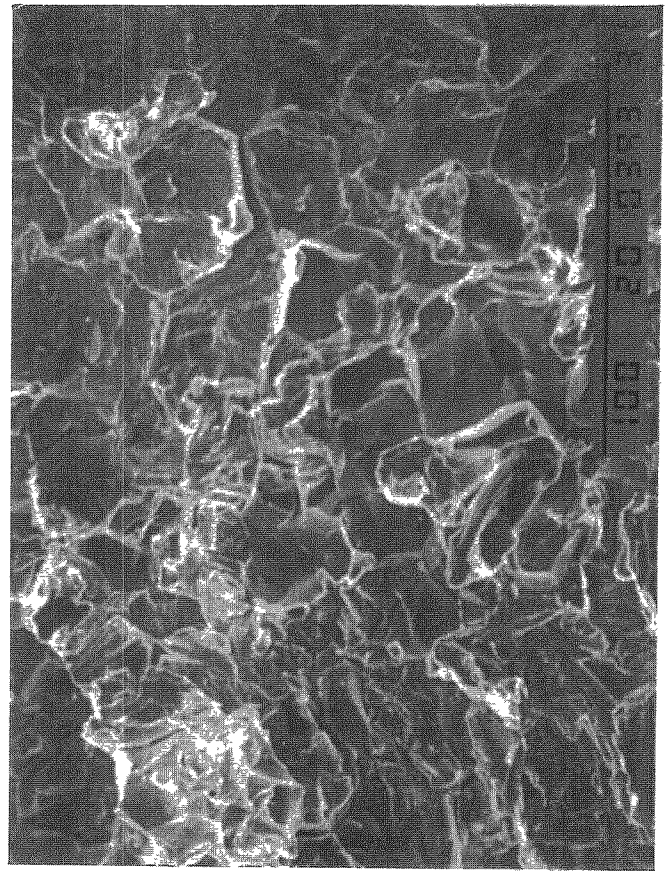
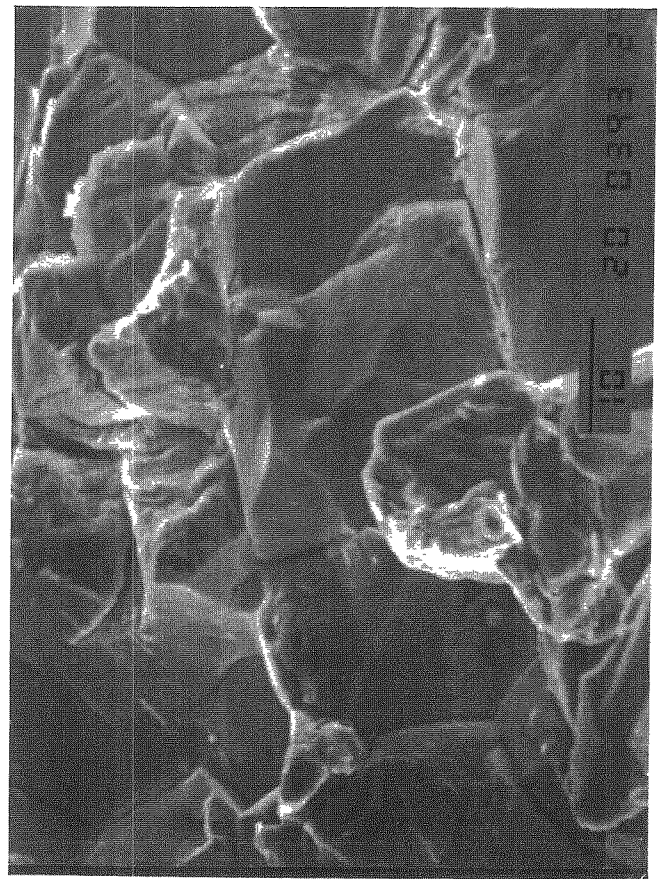
A crack surface was opened to analyze the fracture surface, Fig. 14. The fractographic analysis showed intergranular cracking typical of stress corrosion cracking in austenitic stainless steel.

Fig. 14. Scanning Electron Micrographs (SEM) of opened crack surface.
